The 2011 Tohoku Earthquake and Dams

ICOLD 89th Annual Meeting in Lucerne
June 1, 2011

Japan Commission on Large Dams
N. Matsumoto, T. Sasaki & T. Ohmachi

The 2011 Tohoku earthquake and dams

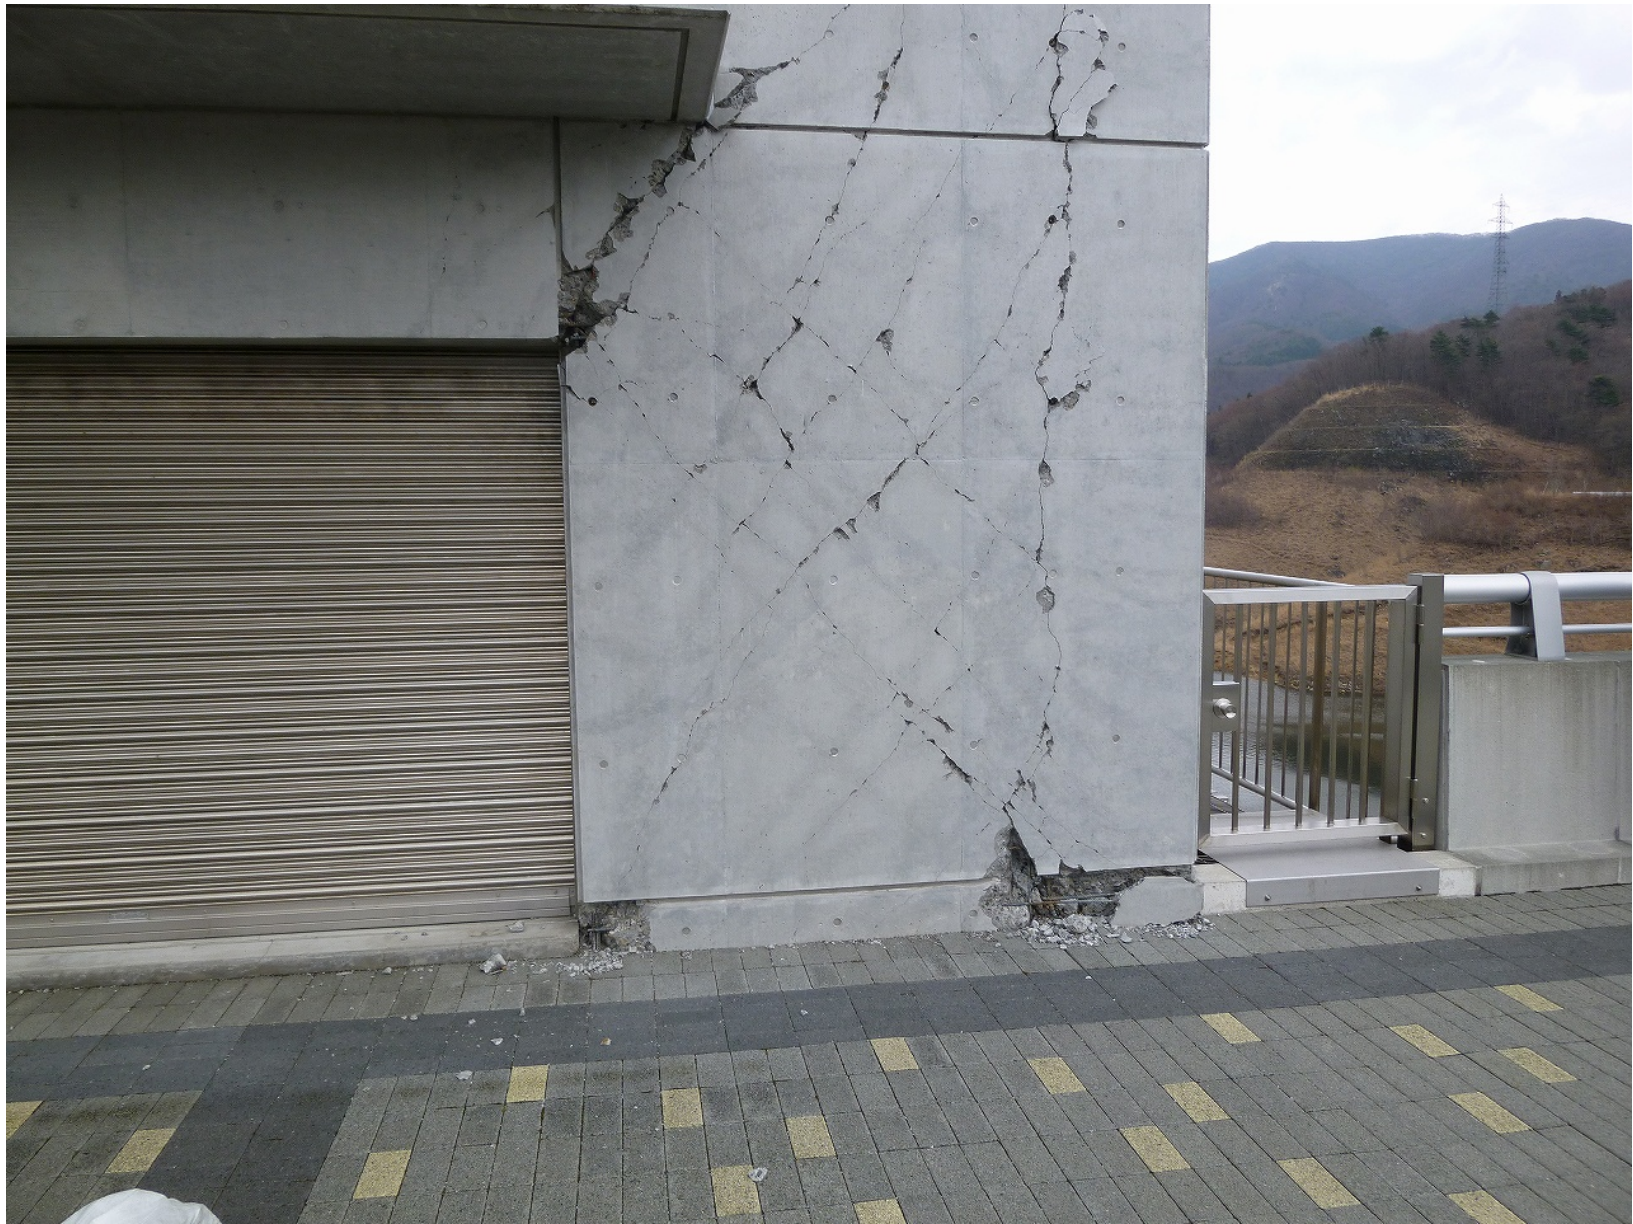
Takou Dam: The wall of gate house was cracked.

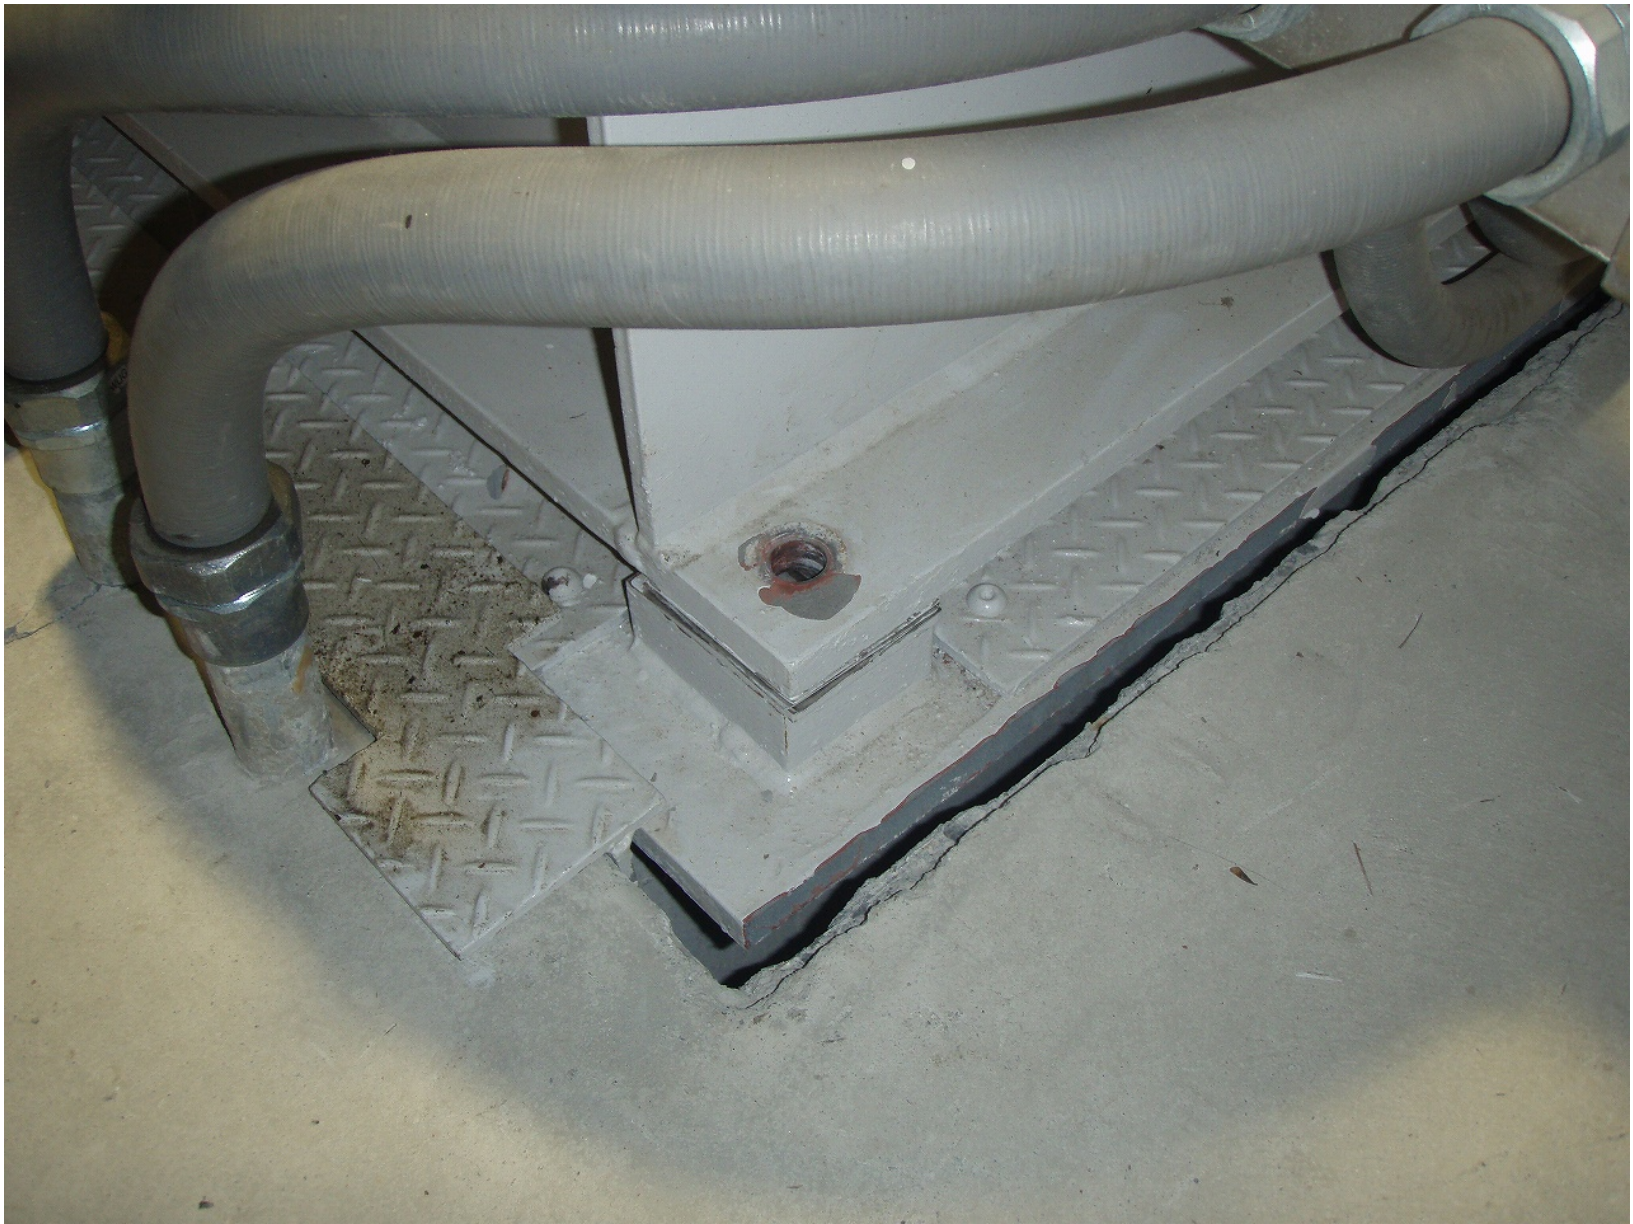
Inside the house, bolts were cut off and the hoist was displaced.

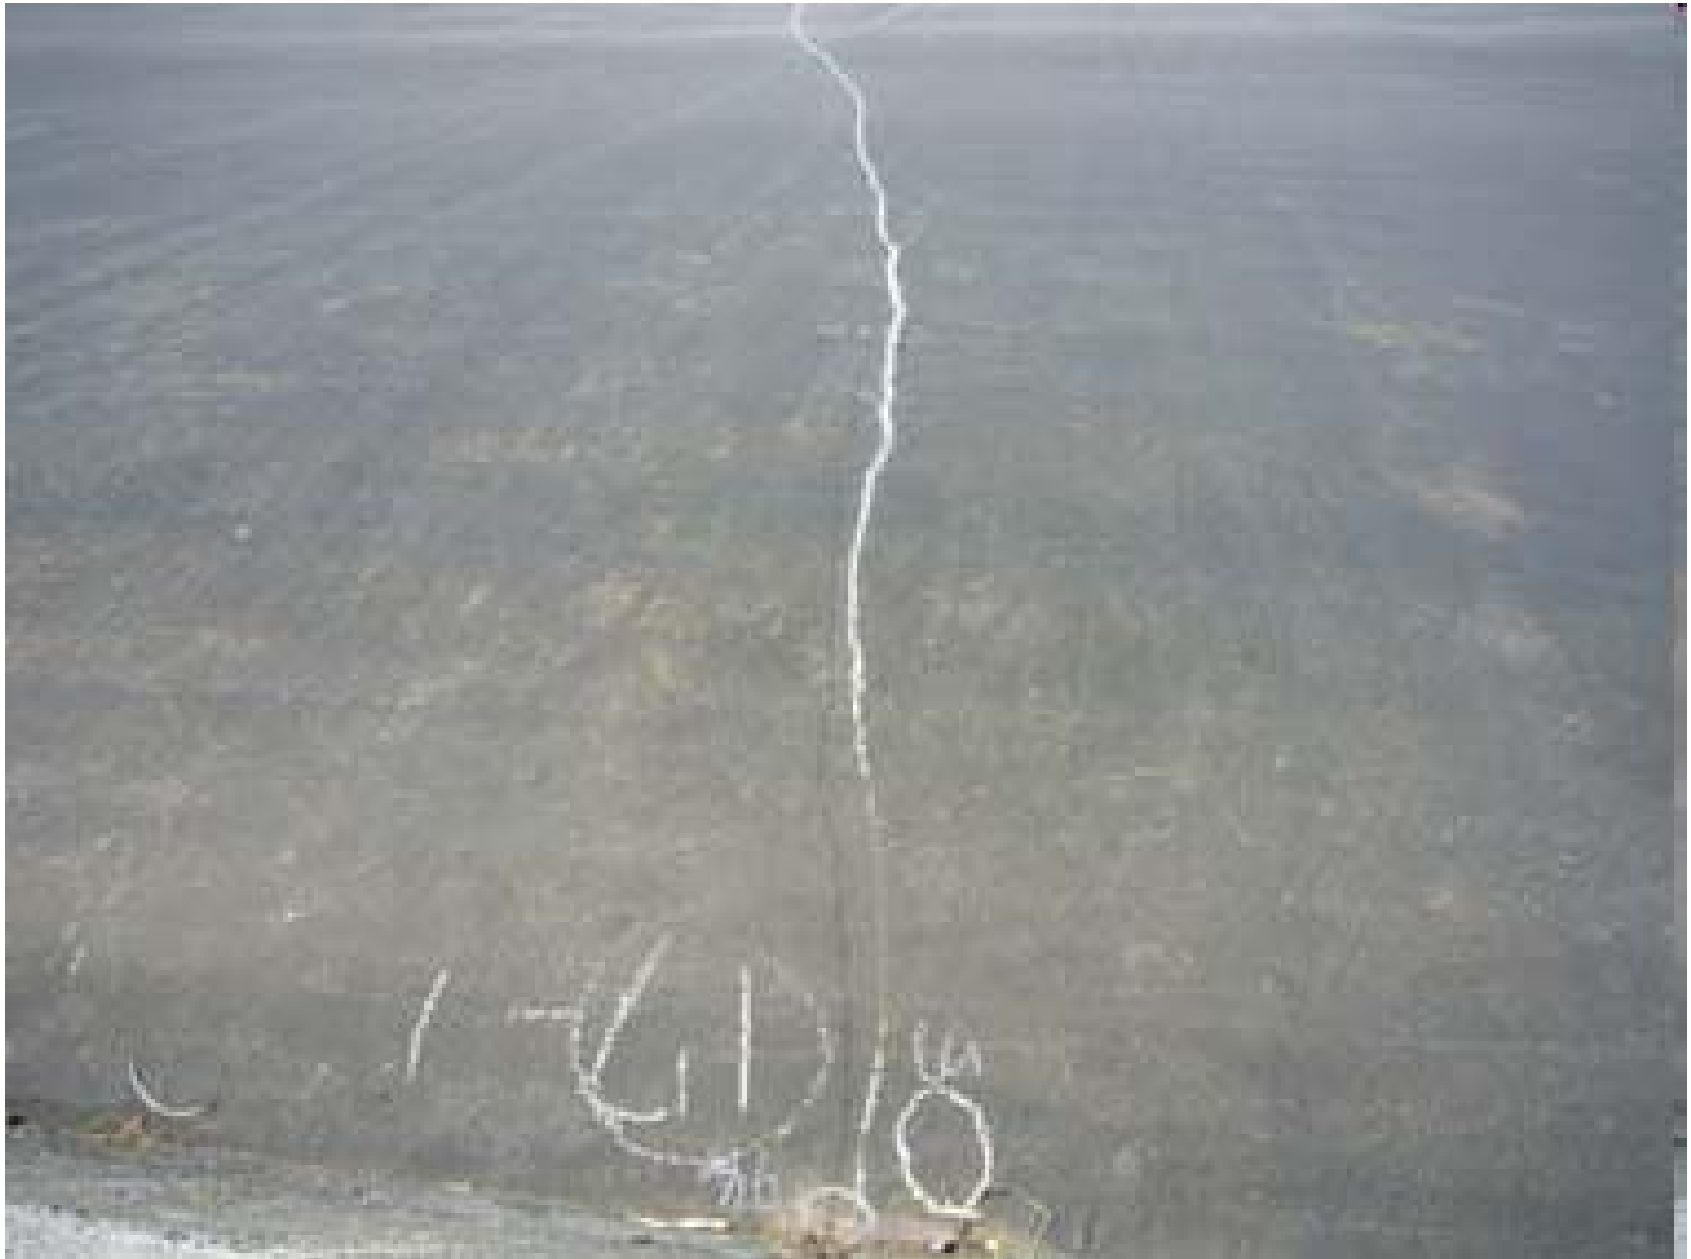
Cracking on the asphalt concrete face Numappara Dam JCOLD

H=38m PGA(fondation)=0.21g PGA (crest)=0.35g

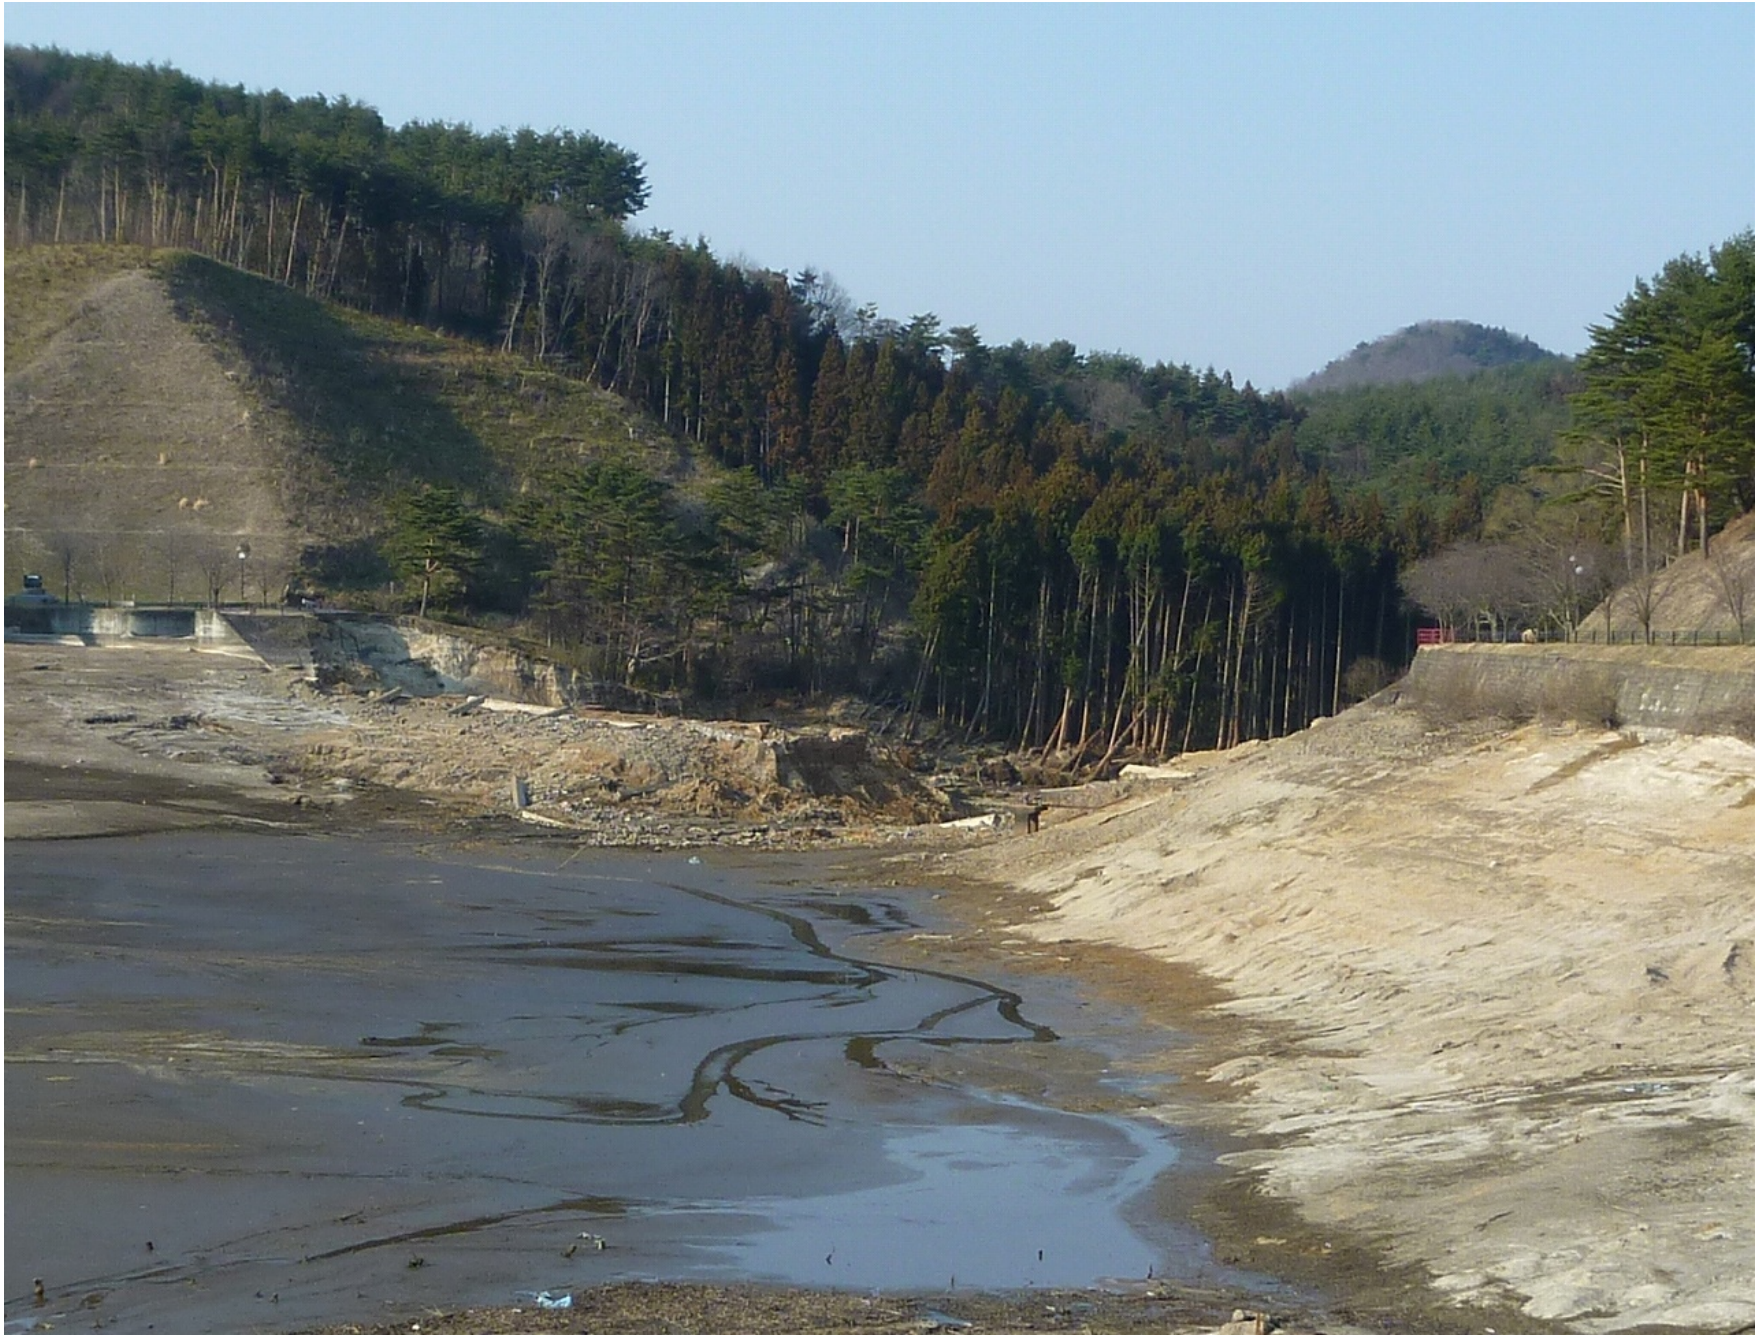
Fujinuma-ike after breach

Fujinuma-ike was breached shortly after the earthquake. It was an earthfill type embankment with the height of 18.5 m and the length of 133 m. The reservoir capacity was 1.5 million m³.

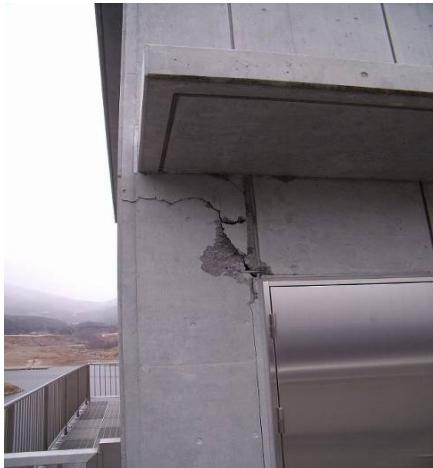
Figure 5. Cracking at gate house

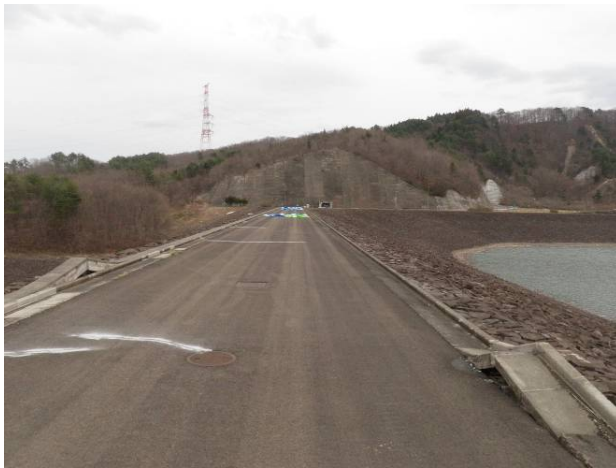
Figure 6. Bump on the crest of Nanakita Dam

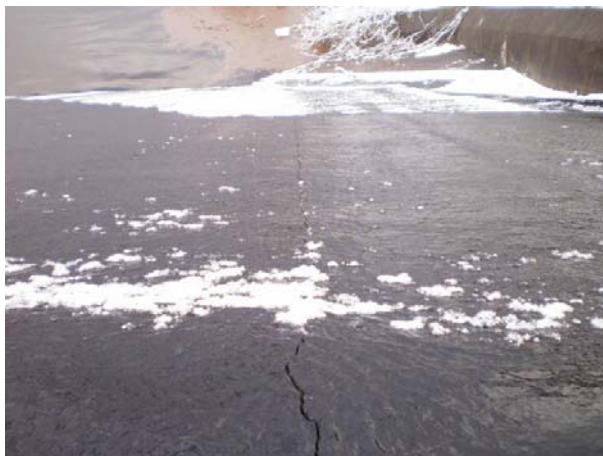
At the time documenting this paper, it is impossible to describe the performance of all dams in the affected areas during this earthquake. This is a very preliminary report. Figure 3 shows the location of major dams and the projection of fault surface. Iwate, Miyagi and Fukushima are severely affected three prefectures. The shortest distance to the fault of these dams ranges 70 to 160 km, if the dip of the fault is taken into account. Figure 4 is Takou dam in Iwate Prefecture. The dam performed very well, but the gate house was cracked as shown in Figure 5. Figure 6 is the photo of crest of Nanakita dam in Miyagi Prefecture. Three fill dams suffered cracking in asphaltic concrete face. Minamikawa Saddle dam is one of them as shown in Figure 7.

Figure 7 Asphaltic concrete face of Minamikawa Saddle Dam

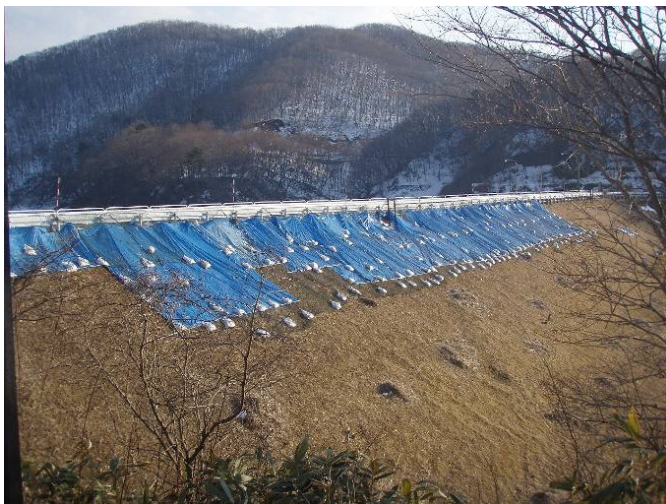
Figure 10. Hatoriko downstream slope

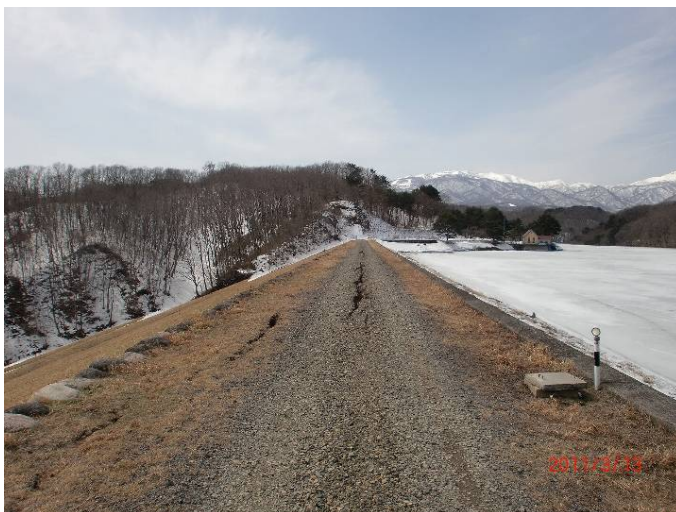
Figure 11. Nishigo Dam; cracking on the crest

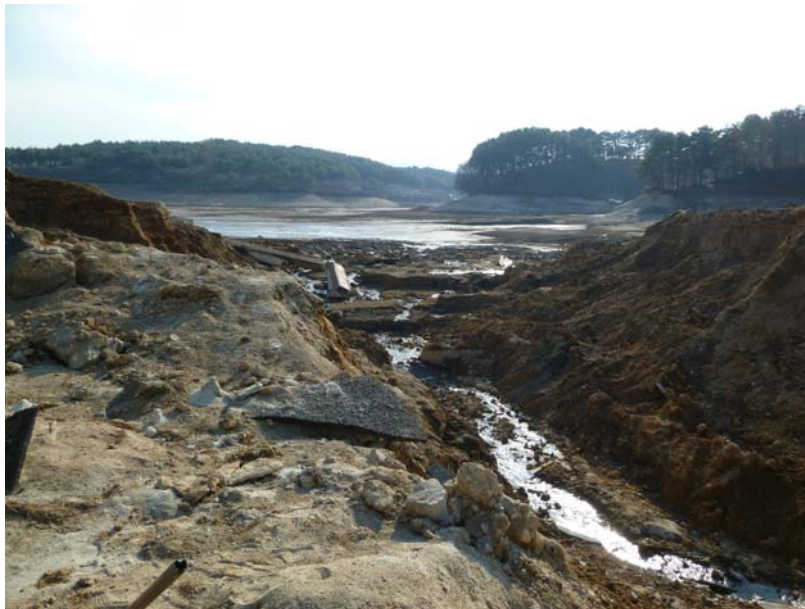
Construction began in 1937 for irrigation and was suspended during World War II. It was completed in 1949. When the earthquake occurred, the reservoir level was almost full. According to witness, 20 to 25 minutes after the earthquake, the water was overflowing on the crest. Later big discharge occurred and it was breached completely as shown in Figures 13 & 14. The embankment had lost the height to retain water. The structure is a homogeneous type and most materials seem to be cohesive soil.

Figure 13. View from downstream toward the Fujinuma-ike

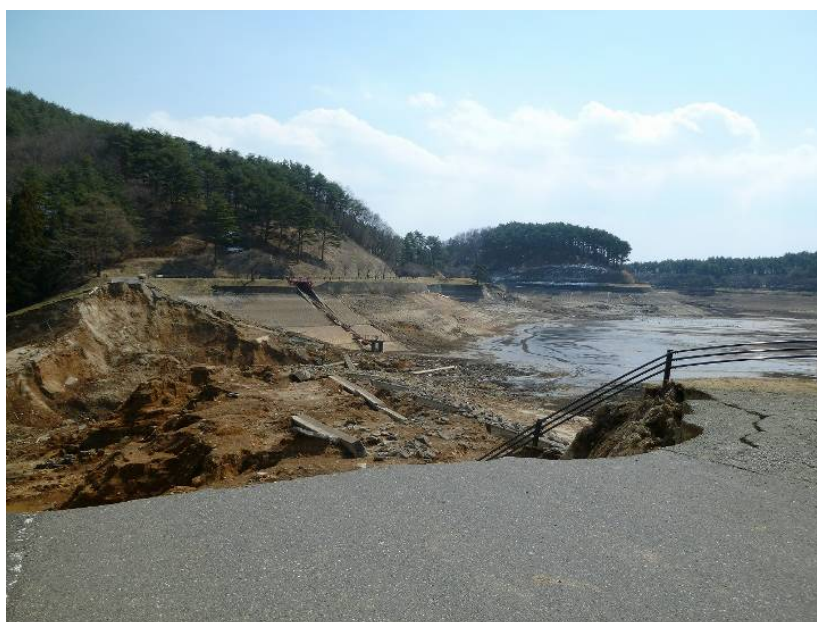
Figure 14. View from left abutment toward the breached portion
